Manhole Inspection Summary

Manhole # S35II_046MH

Insp Date: **3/12/07 1:08 PM**

Location Address: **104 LANVALE ST**

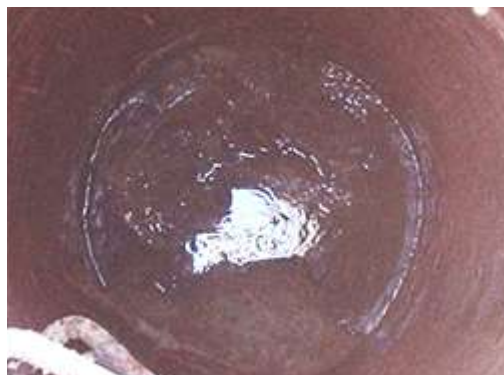
Top View

Active surcharge - 1st visit.

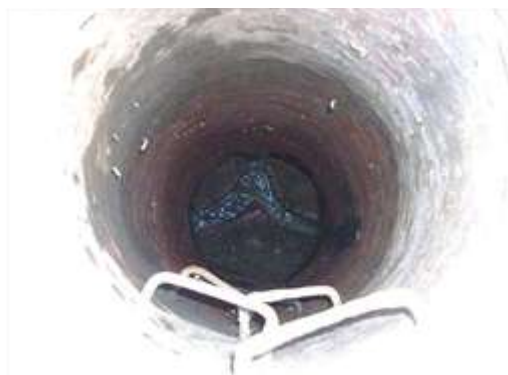
Top View

Bench ☒ Exists Material: **Brick** ☐ Parged ☒ **Debris** (not Condition related)

Steps Count: **10** Missing: **0** ☒ **Corroded**

Surcharge ☒ **Evidence Of Surcharge** Depth: **4.5** (ft.) ☐ Active Surcharge Present

Corroded steps. Evidence of surcharge - Bench debris.

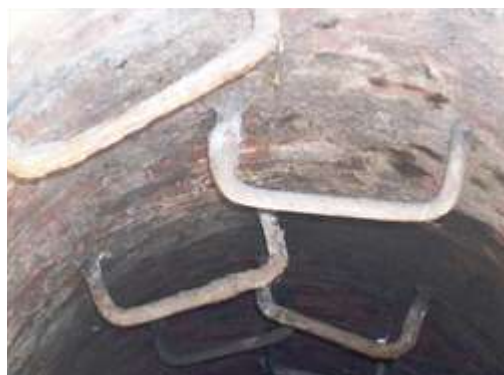
Defect

Infiltration: ☐ None ☒ **Joint** ☐ Cracks ☐ Mortar ☐ Roots ☒ **Wall**

Infiltration: ☐ None ☐ Joint ☐ Cracks ☐ Mortar ☐ Roots ☒ **Wall**

Corroded steps. Adjustment and Corbel infiltration.

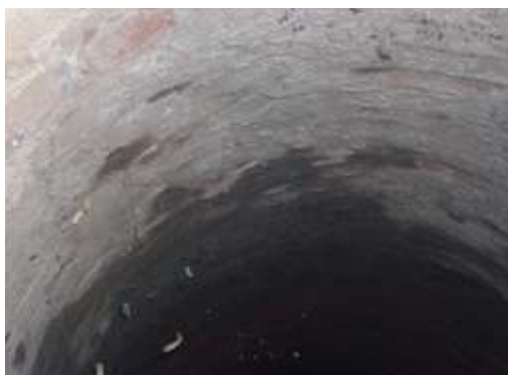
Defect

Corbel infiltration.

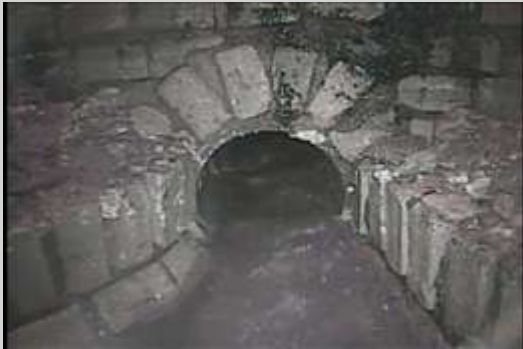
8 in. Circular Gravity Sewer Pipe Out @ 12 O'Clock

Condition: ☐ Sound ☐ Cracked ☐ Root Intrusion ☒ **Deteriorated** ☐ Leaks ☐ Debris

Channel deterioration.

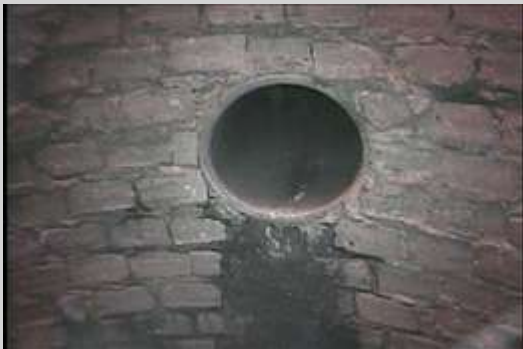
8 in. Circular Gravity Sewer Pipe In @ 3 O'Clock

Infiltration: **Evidence** Pipe Seal Cond: **Unknown**

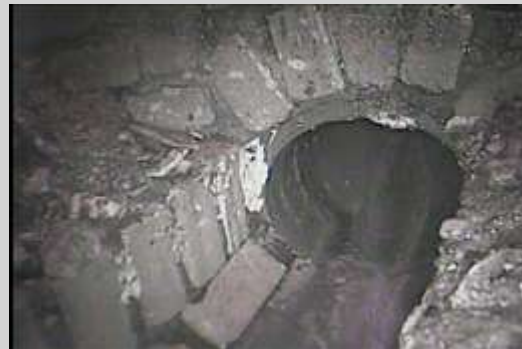
Drop In @ 3 O'Clock

Drop: **Outside** Rod and Bar

Drop Condition: **Open**

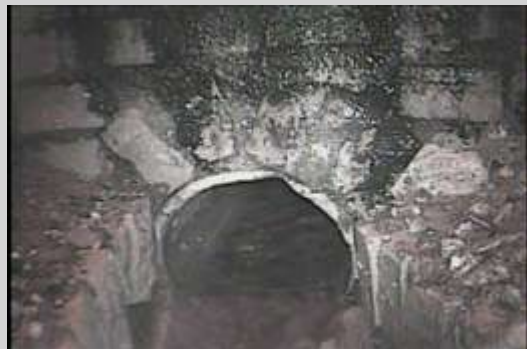
Pipe In @ 9 O'Clock

Pipe Seal Cond: **Broken**
